## CASE REPORT

### Metal Reinforced Complete Denture: A Case Report

Department of Prosthodontics, Chandra Dental College & Hospital, Barabanki, UP, India

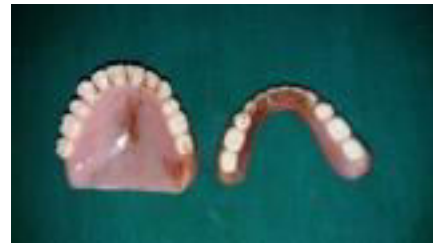
Figure (1) Maxillary & Mandibular Old denture- with fracture line seen in mandibular denture.

A 63 Year old male patient reported to the department of prosthodontics Chandra dental college and hospital with the chief complaint of repeated fracture of mandibular denture (Fig. 1). He had been wearing denture since 7 years and his denture was repaired several times with autopolymerizing acrylic resin. Detailed history revealed that he had the habit of grinding his teeth not only during night but also during day. Denture examination revealed flattened occlusal surface with loss of vertical dimension at occlusion. After thorough examination, a cast metal based mandibular complete denture was planned for this patient.

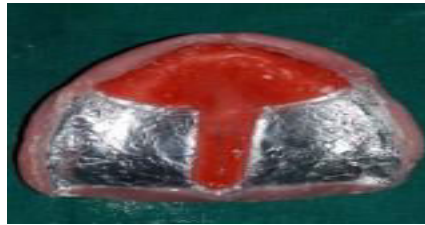
Figure no.(4) Custom tray with T- Shaped spacer adapted in maxillary arch.

1. Preliminary impression for maxillary and mandibular arches was made using patient's old denture with irreversible hydrocolloid (alginate- DPI dust free) impression material and it was poured in type II Gypsum product (fig. 3).
2. The preliminary casts were obtained and custom trays were fabricated with T- SHAPE SPACER on maxillary cast with tin foil adaptation with autopolymerizing acrylic resin (fig.4) .

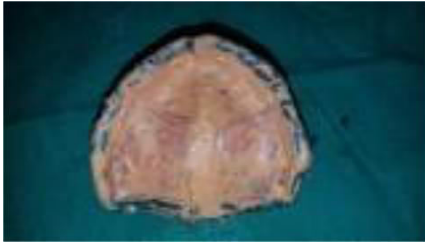
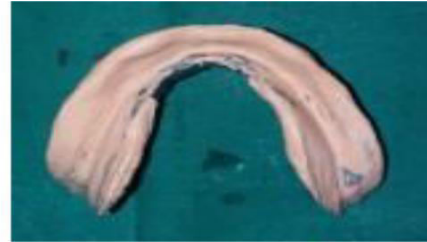
Figure no.(5) Secondary Impression of Maxillary and Mandibular arch (Zinc oxide eugenol paste).

3. Selective pressure impression technique was used for secondary impression. First border molding was carried out conventionally using low fusing impression compound (ROLEX tracing sticks) and then final impression was recorded with zinc oxide eugenol (DPI) impression paste (fig.5).

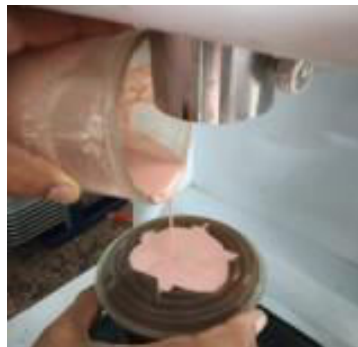
Figure no.(6) Refractory cast poured with ethyl silica bonded investment material.

4. Beading and boxing of the impression was done and it was poured in type III gypsum. Master cast was obtained and the mould of the same was made with reversible hydrocolloid (agar agar) impression material. A refractory cast was poured with ethyl silica bonded investment material (fig.6).

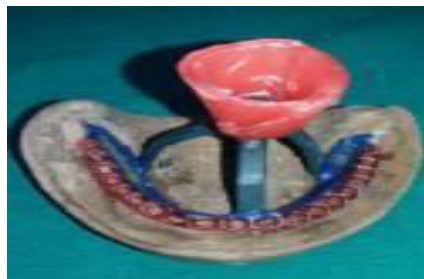
Figure no.(7) Wax pattern and Spruing.

5. On the refractory cast, denture base pattern wax was adapted (fig.7) and then investing and casting procedures were carried out. Metal framework was finished and polished with electrolytic polishing in an electrolytic polishing device.

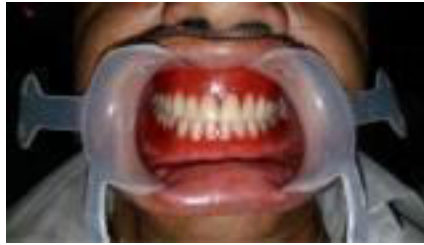
Figure no.(8) Try-in denture in patients mouth.

6. The metal framework so obtained was tried in patient's mouth and was checked for stability and extensions. In mandibular arch the framework ended just before the retro molar pad area (fig. 8).

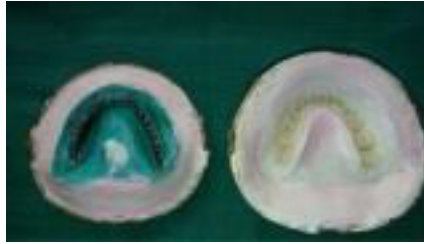
Figure no.(9) ) Curing with metal denture base.

8. Articulation was done followed by teeth arrangement and try in was done in patient's mouth.
9. After trial, the regular protocol of flasking and dewaxing procedure was carried out. Before packing the metal framework was placed on their respective mandibular cast and the acrylization procedure was completed (fig. 9&10).

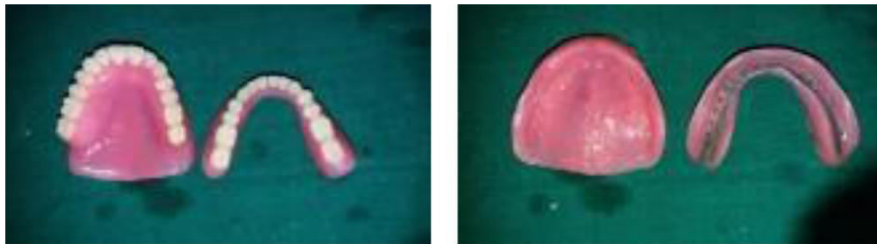
Figure no.(10) Final Denture (a) Cameo surface. (b) Intaglio Surface showing metallic denture base.

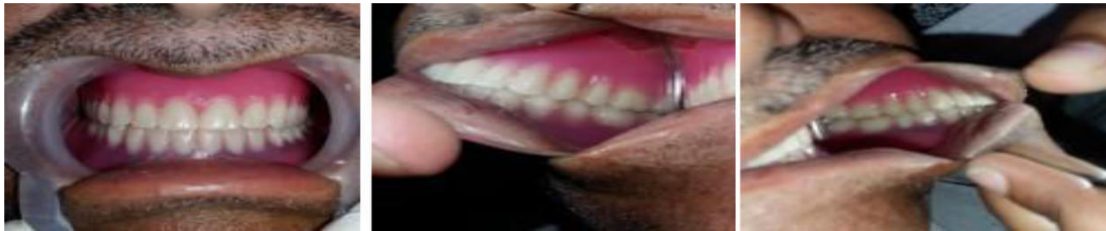
Figure no.(11) Denture in patient's mouth anterior view. (b) Posterior view (right and left side).

10. The prosthesis was then finished, polished and delivered (fig.11,12&13) .
