## Case Report

### Conservative management of large facial mid-root perforation: A Case report

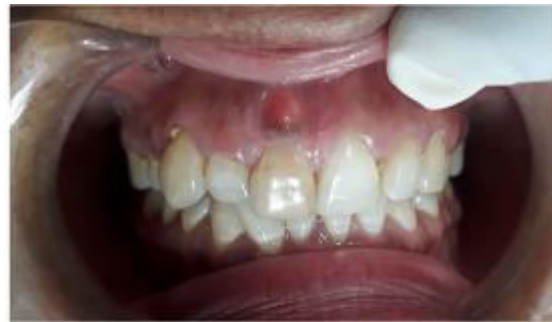
A 25-year-old female patient presented in the OPD with a history of a nonsurgical root canal treatment on the right maxillary central incisor 6 months back. She mainly complained about the recent development of small swelling on the labial aspect with respect to the same

Figure 1: Preoperative image showing swelling on the labial aspect with respect to 11.

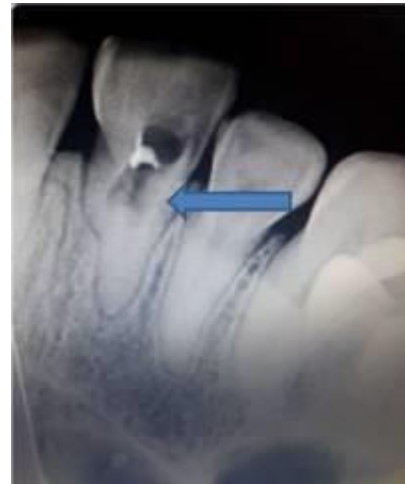
Figure 2: Preoperative IOPA showing a radiolucency superimposed on the canal outline altering it.

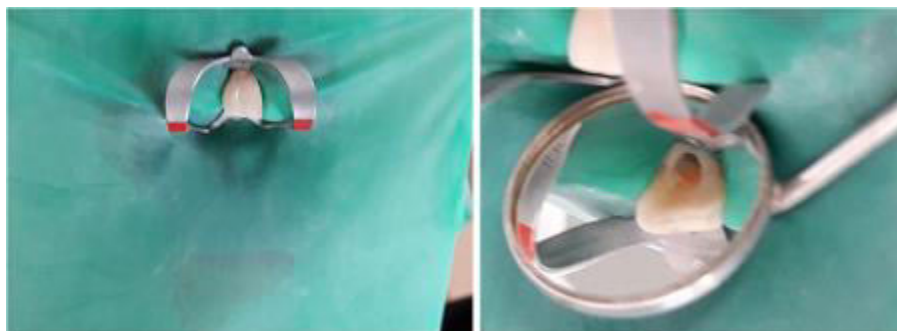
Figure 3: Upon direct examination of perforation site on labial aspect of the root was suspected after removal of temporary restoration under rubber dam.

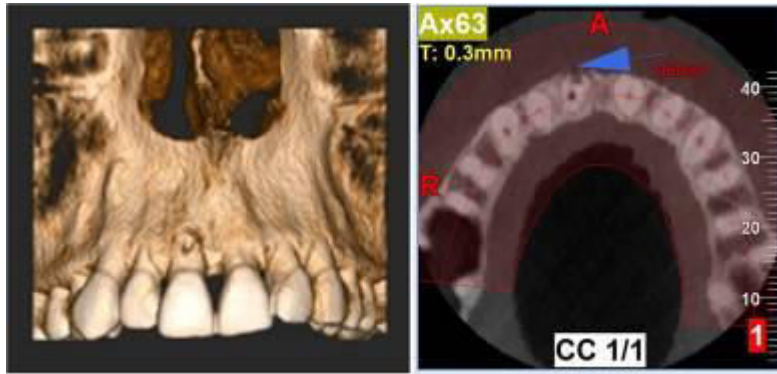
Figure 4: CBCT clearly showing perforation on labial aspect of the root.

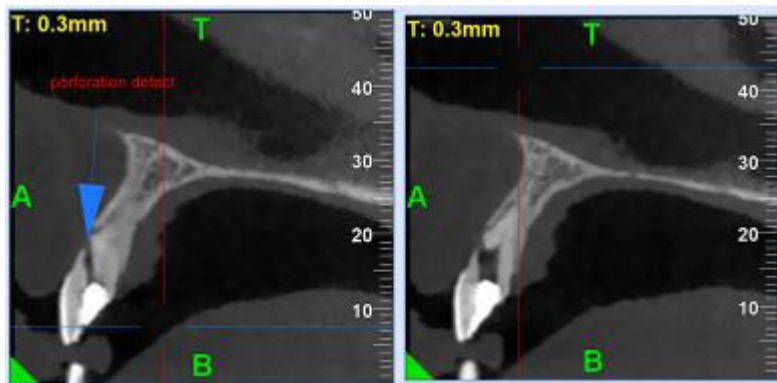
Figure 5: Sagittal section showing perforation at middle third level of the root and a calcified apical third.

In the present case, the perforation was present on the labial surface at the mid third level of root, which might have been caused during access preparation. To avoid such situation anatomy of tooth should be followed while preparing access cavity. Perforation leads to ingress of bacteria and their toxic products from tooth into periodontal and periapical tissues and vice versa resulting in failure of the endodontic treatment.<sup>8</sup>

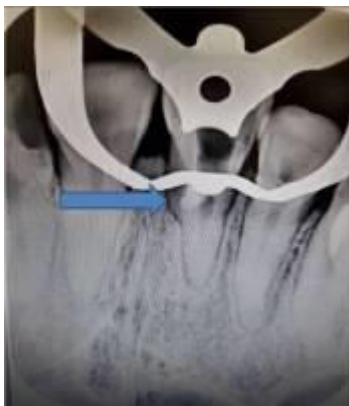
Figure 6: IOPA showing perforation defect completely filled with Biodentine.

The root canal was prepared by circumferential filing using H files with copious amounts of 3% sodium hypochlorite solution (Parcan, Septodont, Saint Maurice-Foss'es, France) between each instrument use. Once the cleaning and shaping was completed, the site of the perforation was cleaned with an ultrasonic tip (ET 18D, Act'eon, M'erignac, France) under sterile water spray. Canal and the perforation site were dried completely. A small moist cotton pellet was packed into the canal at the level apical to the site of perforation, to enclose the canal path and prevent inadvertent falling of the cement inside the canal. Then the mixture of Biodentine powder (Septodont) with liquid was prepared according to the ratio recommended by the manufacturer . A first amount of the mixture was carried with a Micro Apical Placement System (Dentsply)), the excess of moisture was blotted with the blunt tip of a sterile paper point in order to stabilize the cement in situ, and the defect was completely filled in successive increments of material (Figure 6). The tip of a paper point was cut off and moistened with sterile water before being placed in contact with the dampened cement. Then a master cone x ray was taken and canal was obturated with the help of Gutta Percha and sealapex sealer according to the Schilder's warm vertical condensation technique (Figure 7). The access cavity was

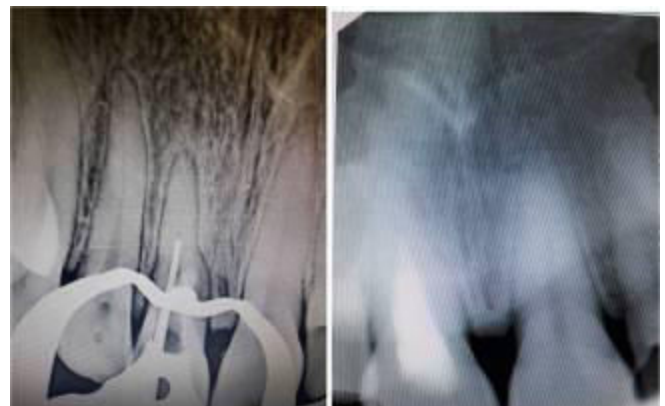
Figure 7: 11 obturated with the help of Gutta Percha and sealapex sealer.

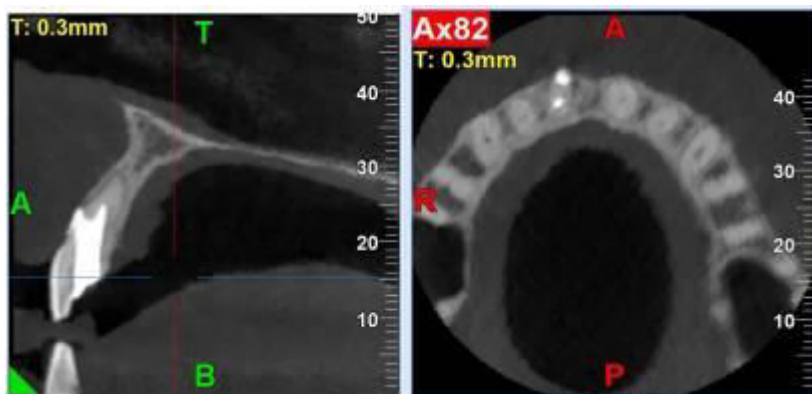
Figure 8: Post operative CBCT showing complete sealing of perforation defect and canal.

filled with a glass ionomer cement (Ketac Fil, 3M ESPE, Saint Louis, MN) covered with a resin composite restoration (EsthetX, Dentsply Caulk, Milford, Delaware). Post operative CBCT was taken to confirm the complete sealing of perforation defect and canal (Figure 8).

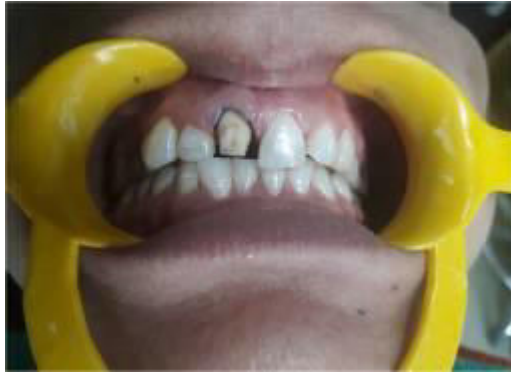
Figure 9: Tooth prepared for All ceramic crown.

At the recall appointment after 3 weeks, tooth 11 was completely asymptomatic, the swelling had disappeared. Then the case was planned for an All Ceramic crown. Tooth preparation was done (Figure 9) and All ceramic crown was placed rehabilitating the total form and function of tooth (Figure 10). Case was followed upto 18 months showing no sign or symptom either clinically or radiographically (Figure 11).

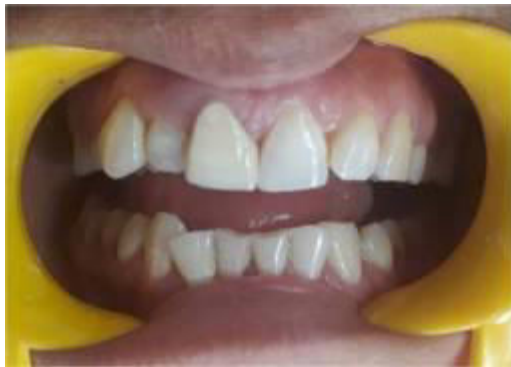
Figure 10: Tooth prepared for All ceramic crown.

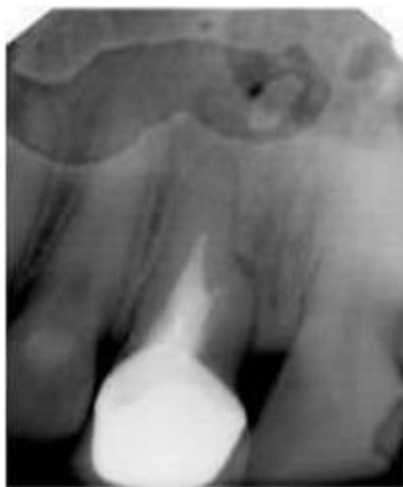
Figure 11: IOPA after follow up of 18 months showing no periapical or periodontal changes.
