Case Report

Management of fractured anterior tooth using fiber post: A case report

^{1,2,3,4,5,6,7}Post Graduate, Department of Conservative Dentistry and Endodontics, Pacific Dental College and Hospital, Udaipur, Rajasthan, India

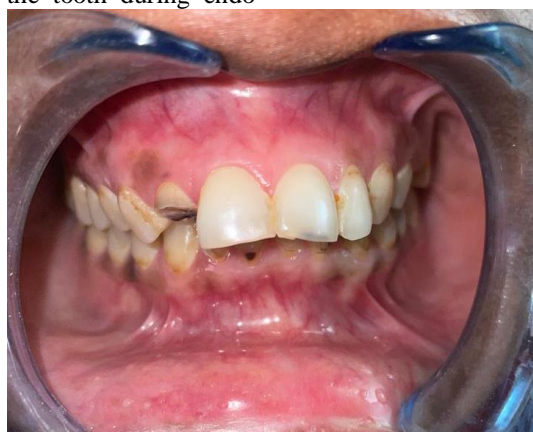
FIG: 1 Preoperative Photograph

A 43years old Female patient reported to department of Conservative dentistry and endodontics, with a chief complaint of fractured upper front teeth with a unaesthetic appearance of face since 2 yrs after sustaining trauma due to accidental fall.The right lateral incisor was fractured and was not tender on percussion. Radiographic examination revealed radiolucency involving enamel, dentine, and pulp. Vitality test was done and the tooth gave a negative response.Hence, it was concluded that the tooth was non vital.

Ellis class IV fracture was diagnosed during intraoral examination.Treatment was decided to restore the complex crown fracture with fiber post and core followed by crown.
