Case Report

“Sacrificing a tooth not always an option”; instrument retrieval from calcified central incisor – A case report.

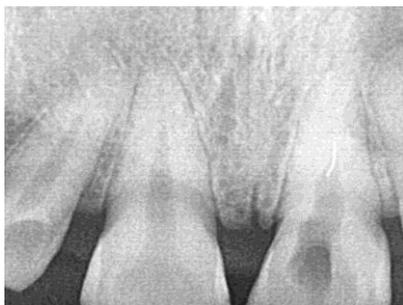
separated instrument and the prognosis of the tooth and consent was taken (FIGURE – 1).

FIGURE 1- Pre operative radiograph of tooth with fractured file segment.

Routine endodontic treatment with instrument retrieval was planned for the patient. After complete history taking, local anaesthesia was administered to the patient. The concerned tooth 21 was isolated using rubber dam. The temporary filling material was removed. Starting with an ISO # 8 K-file, and attempt was made to bypass the instrument at working length. Progressively, ISO # 8, no d finer (Mani Co. In), 8 no c plus file (DENTSPLY)files were used (FIGURE -2).

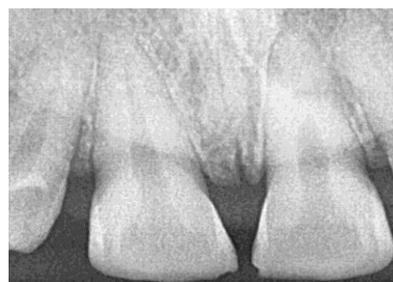
FIGURE 3 – Radiograph taken after file retrieval

Subsequent biomechanical preparation was done using progressive files along with EDTA and sodium hypochlorite for irrigation days. Calcium hydroxide dressing was placed for 7 days. No pain was observed after 7 days. After removing the temporary filling, the calcium hydroxide dressing was removed from the canal of the tooth and the canals were thoroughly irrigated. After biomechanical preparation up to 25/6, the separated fragment became little loose in the canal. Ultrasonic GOLDEN tips (ORIKAM) were used to loosen it further and then irrigated it thoroughly to retrieve the fragment. RVG was taken to confirm the complete retrieval (Figures 3).

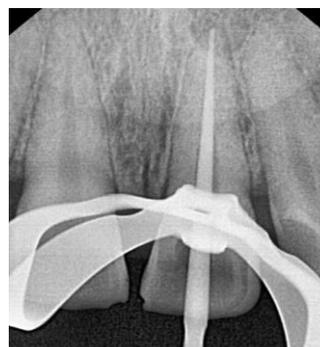
FIGURE 5 – Mastercone selection done

After the retrieval, through irrigation with 3% Sodium Hypochlorite was done. Master cone selection was done (Figure- 5).

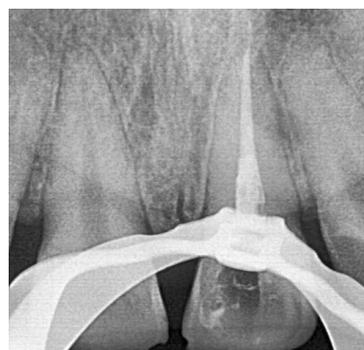
FIGURE 6 – Obturation after file retrieval

Canals were dried with paper points and obturated using Cold Lateral Compaction Technique using AH PLUS sealer. (Figure 6).
