Case Report

Sub gingival crown en masse fracture: A Case Report

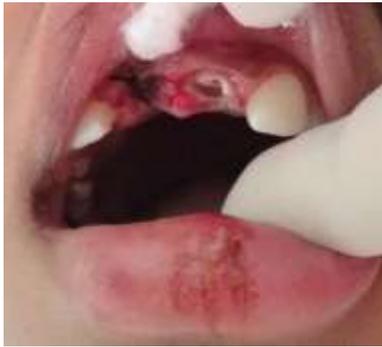
Fig 1. Pre treatment photo (suturing done wrt 11)

A healthy 15 year-old female reported in dental clinic after suffering trauma to her maxillary incisors, following a motorbike accident occurred 90 minutes before. Extra oral examination revealed no injury to facial bone and TMJ, laceration of lower lip was present. Intraoral examination showed avulsion of tooth 11; crown en mass fracture of tooth 21. Patient has left the tooth 11 at accident site, bleeding was present with respect to socket of 11, gingival crevice of 21 and lower lip. Spontaneous pain was present in the region of maxillary incisors. With the parents' and patient's informed consent, a local anesthetic was administered. Suturing was done to arrest the bleeding from the socket of tooth 11 (Fig 1). Root canal procedure was

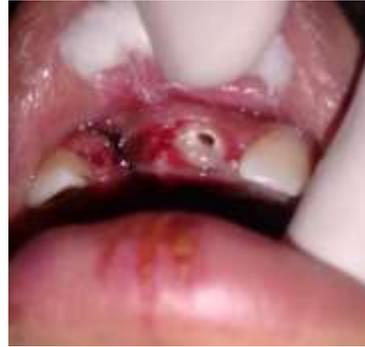
Fig 2. Intraoral photo after BMP and composite rebuild wrt 21.

initiated for the tooth 21. As the crown fracture was subgingival, crown build up was done with restorative composite, so that it can hold intracanal medicaments (Fig 2). Oral antibiotic (amoxicillin 500 mg thrice daily for 5 days) and analgesic medicament on need basis were prescribed. The patient received instructions about an appropriate soft diet and about an adequate oral personal hygiene (chlorhexidine 0.12% mouth rinse twice a day for 1 week and a soft toothbrush to brush her teeth after each meal). After 3days, 21 was obturated (Fig. 3). After 7 days of trauma, on patient's third visit to the dental clinic suture were removed and post and core build up of 21 was completed. Coronal two third of gutta-percha was removed with peso

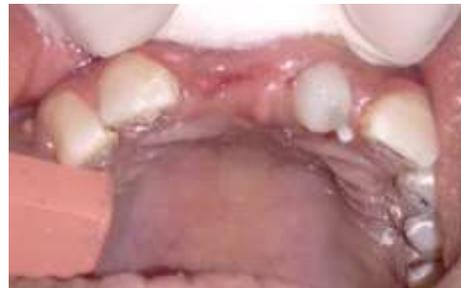
Fig. 4 Intraoral photo showing post and core build-up wrt 21.

reamer and radiographically evaluated. Glass-fibre post with composite was used as post and core material (Fig 4, Fig5). Patient and parents' were not interested in implant for tooth 11. Cantilever bridge was planned involving 31, 21 and 11. Crown preparation of 31, 21 and 21 was done (Fig 6). Impression was made and model was sent to laboratory for the crown manufacturing.

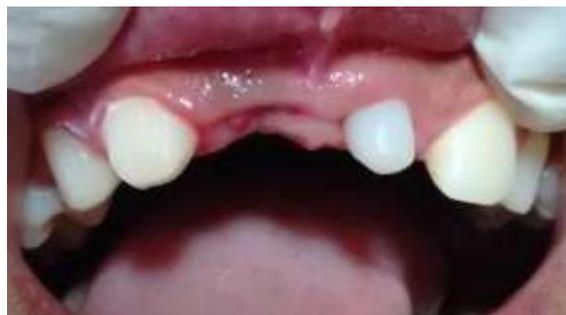
Fig 6. Intraoral photo showing post and core done wrt 21 and crown preparation done wrt 31 and 21.

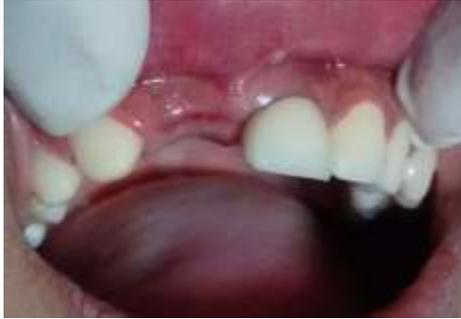
Fig 7. Porcelain fused to metal crown given wrt 21.

Next day, crown was given on tooth 21(Fig. 7) and cantilever bridge was given for prosthetic rehabilitation of 11 (Fig. 8). The patient was scheduled for follow-up and was monitored weekly in the first month after the trauma, then after 3 months, 6 months and 1 year.

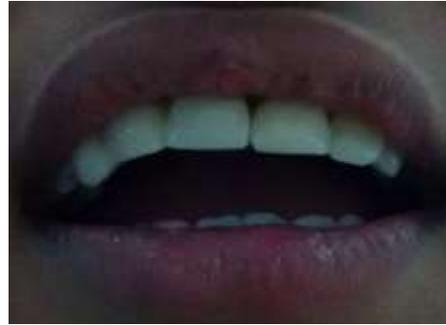
Fig. 8 Post operative photo showing PFM cantilever bridge wrt 31,21 and 11 and PFM crown wrt 21.
